## MKX<sup>2</sup>1083 LIFT-ASSIST INTERFERENCE – FIELD FIX BULLETIN

| ECN ID # | 4401 |
| MODEL | MKX <sup>2</sup> 1083 |
| DETAILS | MKX <sup>2</sup> 1083 lift-assist interferes with the lower truss bracket. |

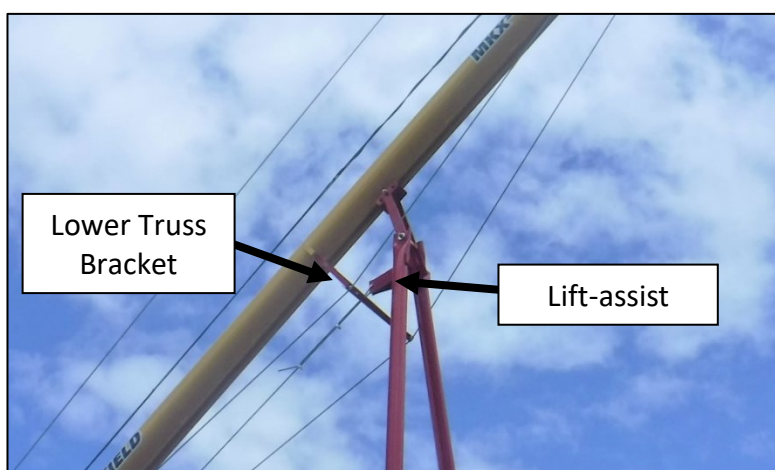
Many MKX2013 augers were shipped with the incorrect stroke limiter plate causing the lift-assist to interfere with the lower truss bracket when fully raised.
