# **SERVICE BULLETIN**

PRODUCT: GRAIN VAC

SUBJECT: SERVICE TIPS FOR SHEAR SPROCKET ASSEMBLY

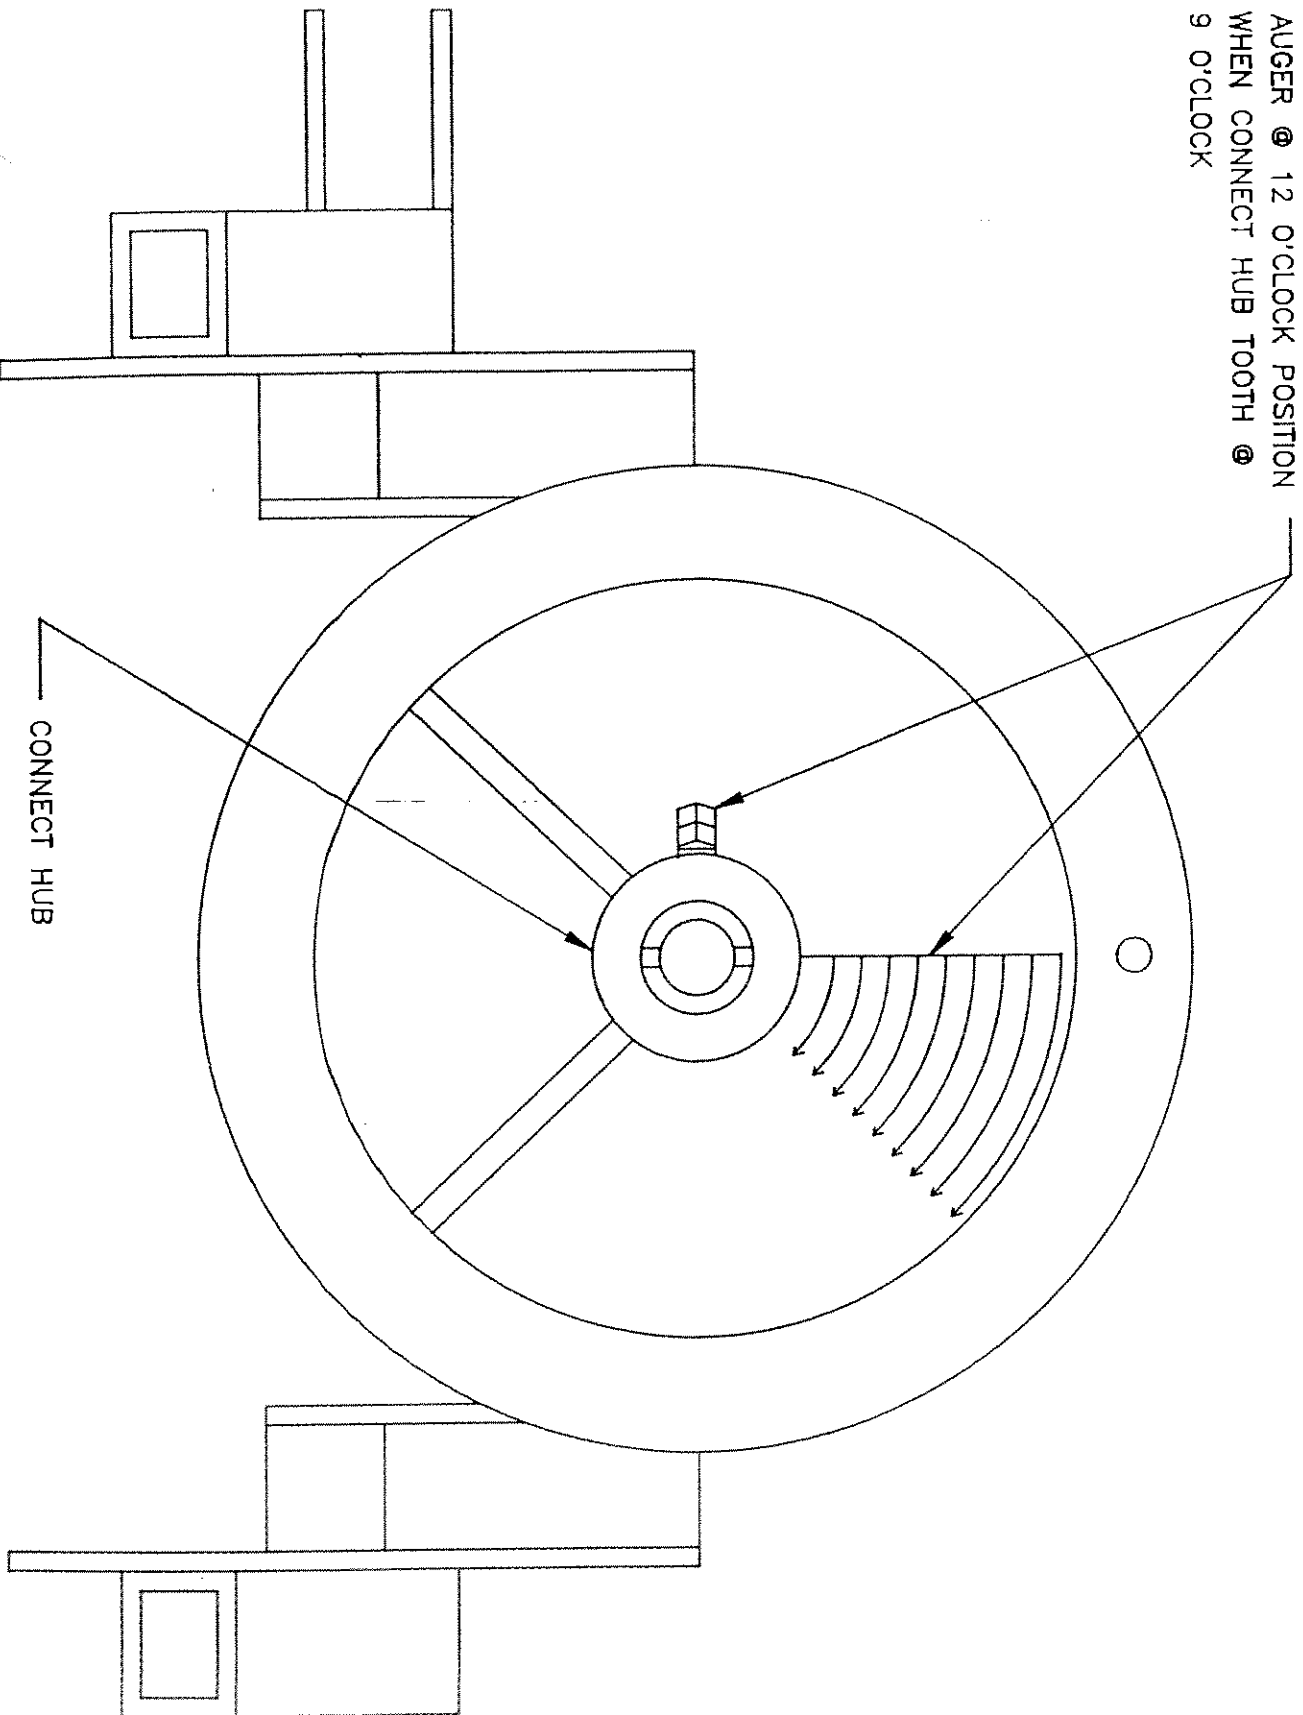
MIDDLE AUGER

AUGER @ 12 O'CLOCK POSITION  
WHEN CONNECT HUB TOOTH @  
9 O'CLOCK

Augers on your 1026 are made up of three separate sections: lower, middle, and upper. Here are some tips on successful replacement and maintenance of these augers. Augers are set at both hinged points to ensure proper locking of auger drives during operation. Failure to set the augers properly may result in the connector weldments skipping, causing damage to auger flying.

The middle section requires a similar procedure. On the bottom end of your auger, the flat surface on the connector hub should be flush with the auger tube. You can move it by adjusting the auger back and forth. To move this auger, you have to loosen the setscrews on the middle auger supports. When the auger is in place, be sure to secure the setscrews using Locktight.

These procedures are necessary to correctly align the auger, and should be done whenever the augers are removed for replacement or repair. See drawing for details.

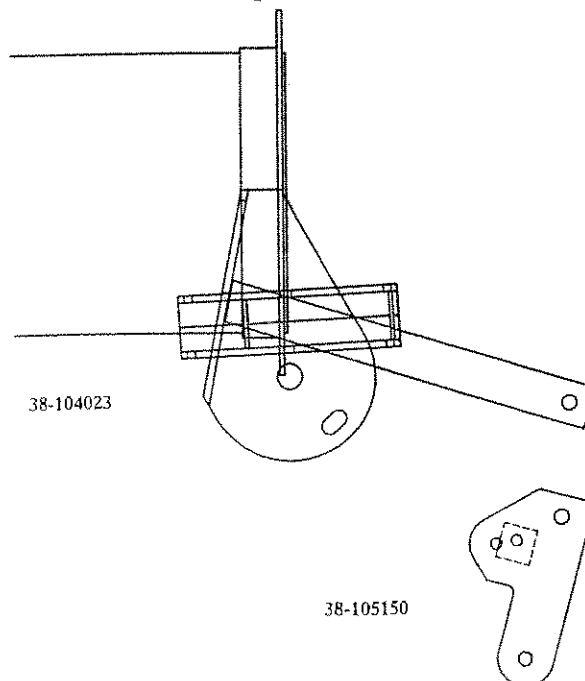
We have changed the 1026 middle auger clevis to allow the customer to adjust the amount of force required for moving the unloading auger in and out of transport positions. Now when your customer orders part # 38-104023, he will require the update kit, part number 38-105150. See drawing for details.

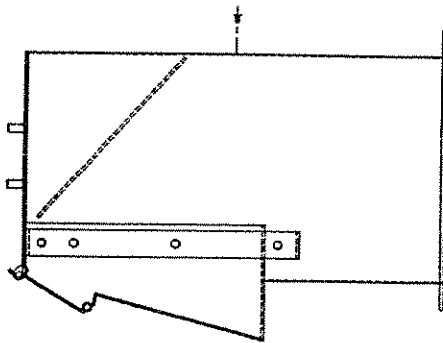
38-105165-7

We have developed a new dumper with a replaceable ultra-high molecular weight polyethylene liner, which increases life over our original steel configuration. If your customer wants to replace his 1026 dumper, he will require the new assembly, part number 38-105165-7, along with the adaptor kit, part number 38-104781. See drawing for more information.

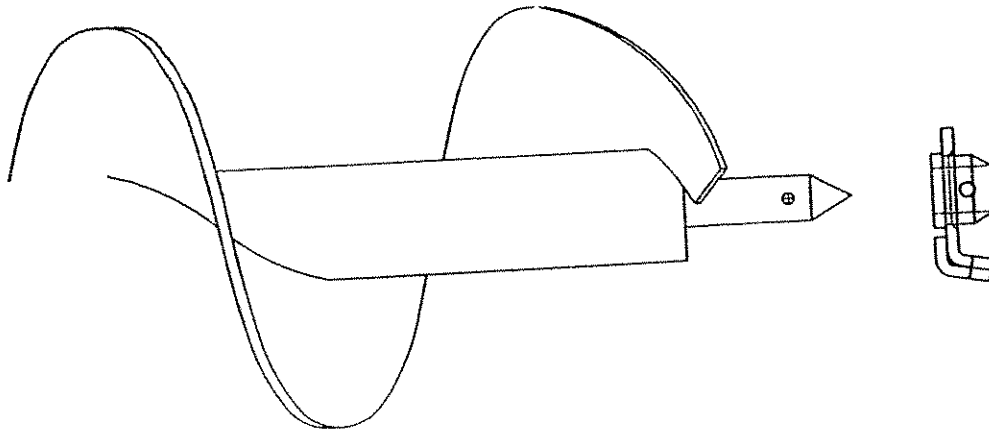
We have increased the diameter of the auger drive connector hub's steel pin from a 1/4" to 5/16". When your customer orders a Connector Hub, part number 38-104066, he will have to drill out the shaft ends of his middle auger, part number 38-104061, to accommodate the new sizing. See drawing for more details.

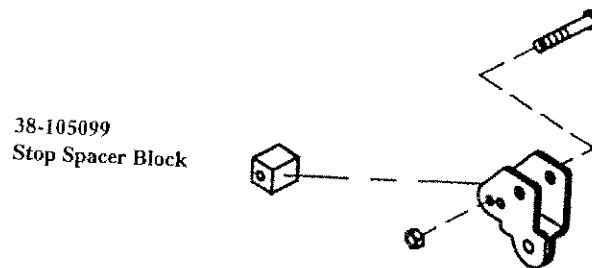
1. Elevate the auger
2. Loosen the 3/8x2" bolt (do not remove)
3. Rotate the block by 1/4 turn either way
- CAUTION: WATCH OUT FOR YOUR FINGERS!**
4. Tighten the bolt

Refer to page 9 and 9A in your 1026A parts catalog for a complete diagram of this assembly, and bulleting # 8 for model 1026 application. See drawing for details.

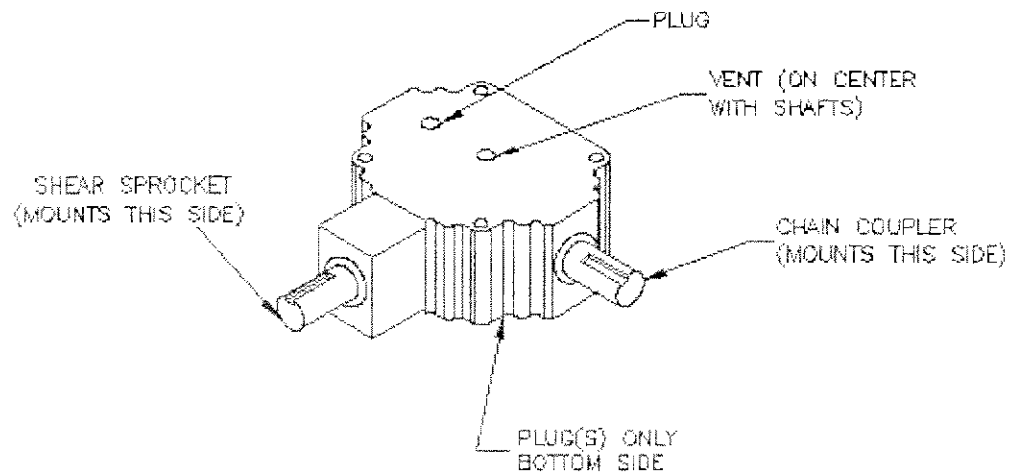
## 1026B GEARBOX (PLUG & VENT LOCATIONS)

To affected Rem Grain Vac Dealers. We have had one incident where the gearbox plugs on the 1026B Grain Vac were reversed. We have narrowed down the cause to a factor that may have affected the first 1026B production run in 1999. We feel it is in your customer=s best interest to ensure that the machine you have purchased (see serial number below) is not affected. Please check the plugs according to this drawing: the vent plug should be on the highest level, and the solid plug on the lower. See attached diagram for details.

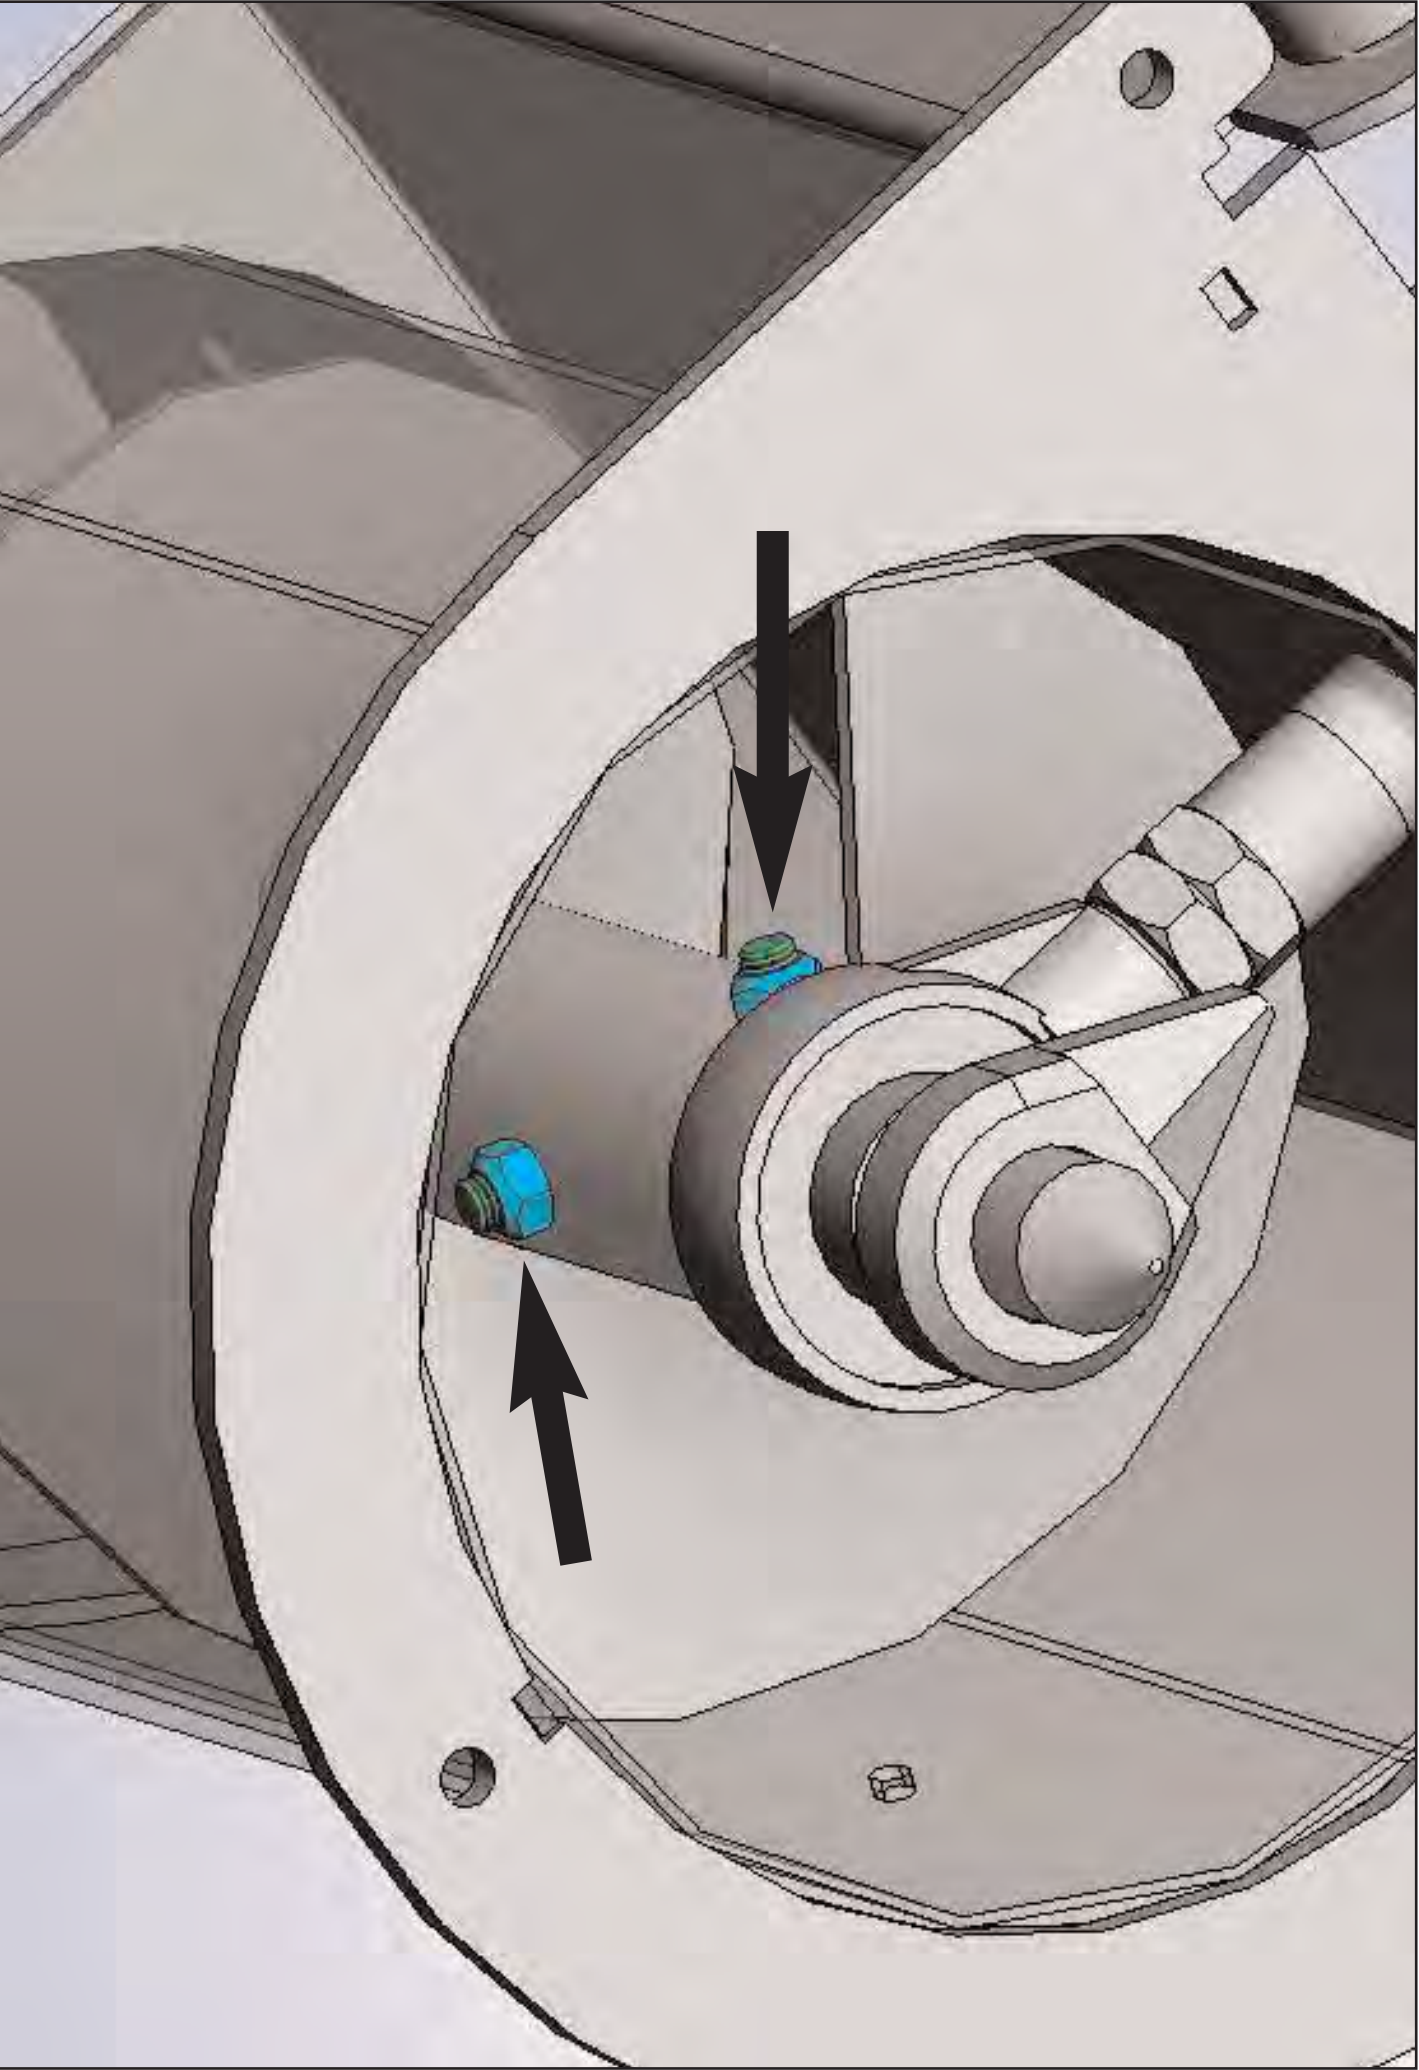
**SERVICE BULLETIN FIGURE 1**

In some cases the bolts holding the drive shafts in place on the auger flyting have loosened.

**Grain VAC 3700: AUGER BOLT INSPECTION**

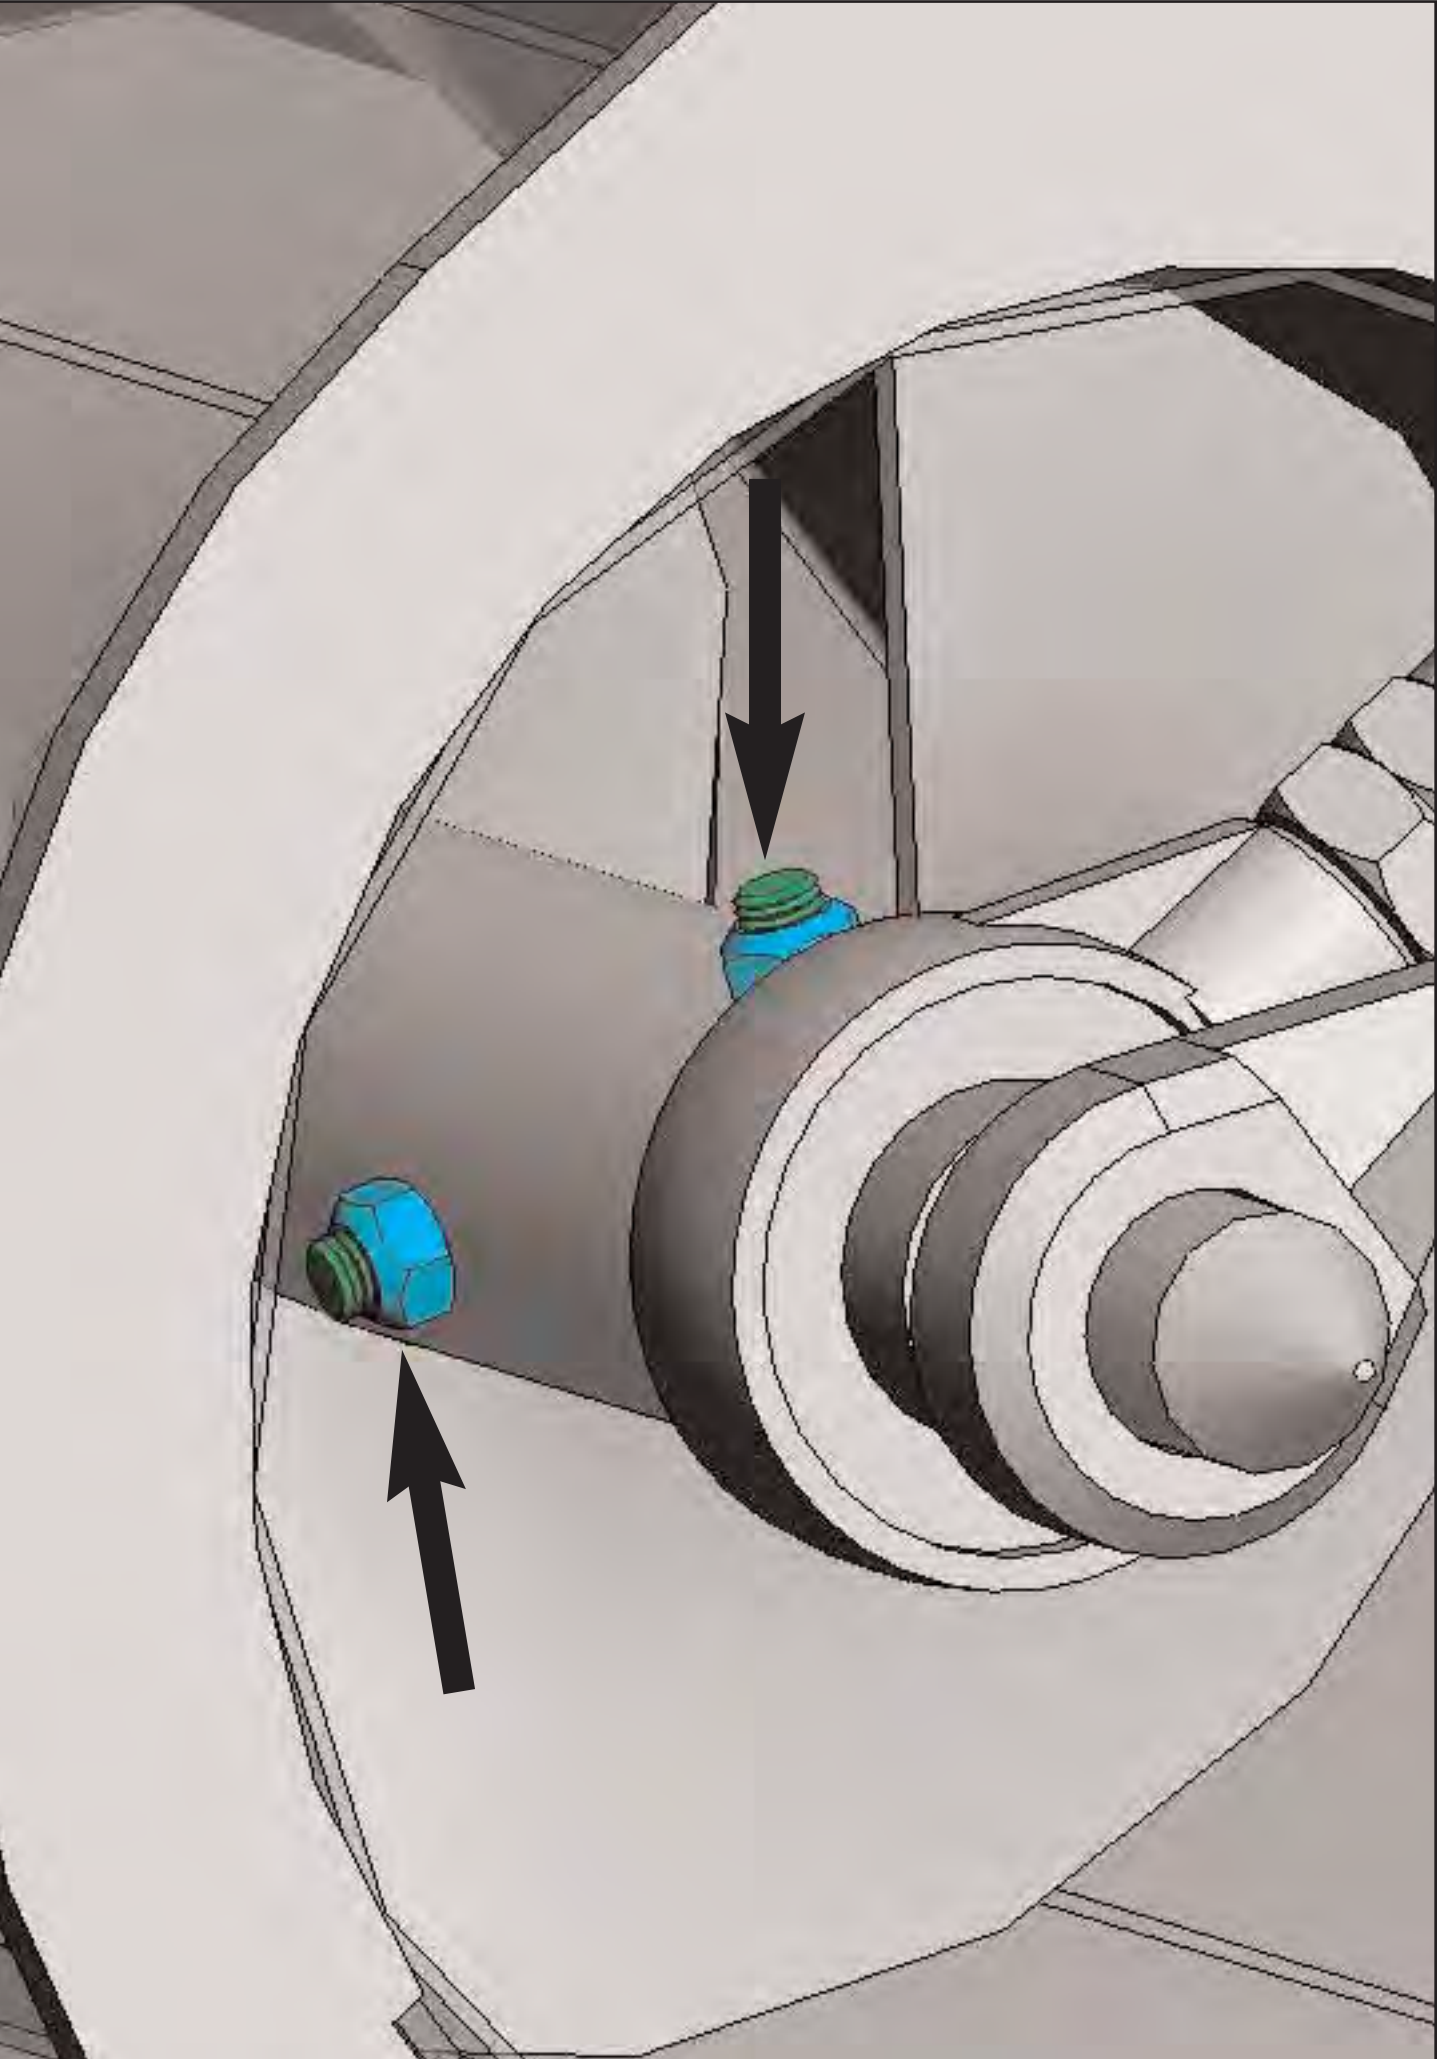
**SERVICE BULLETIN FIGURE 2**

**Grain VAC 3700: AUGER BOLT INSPECTION**

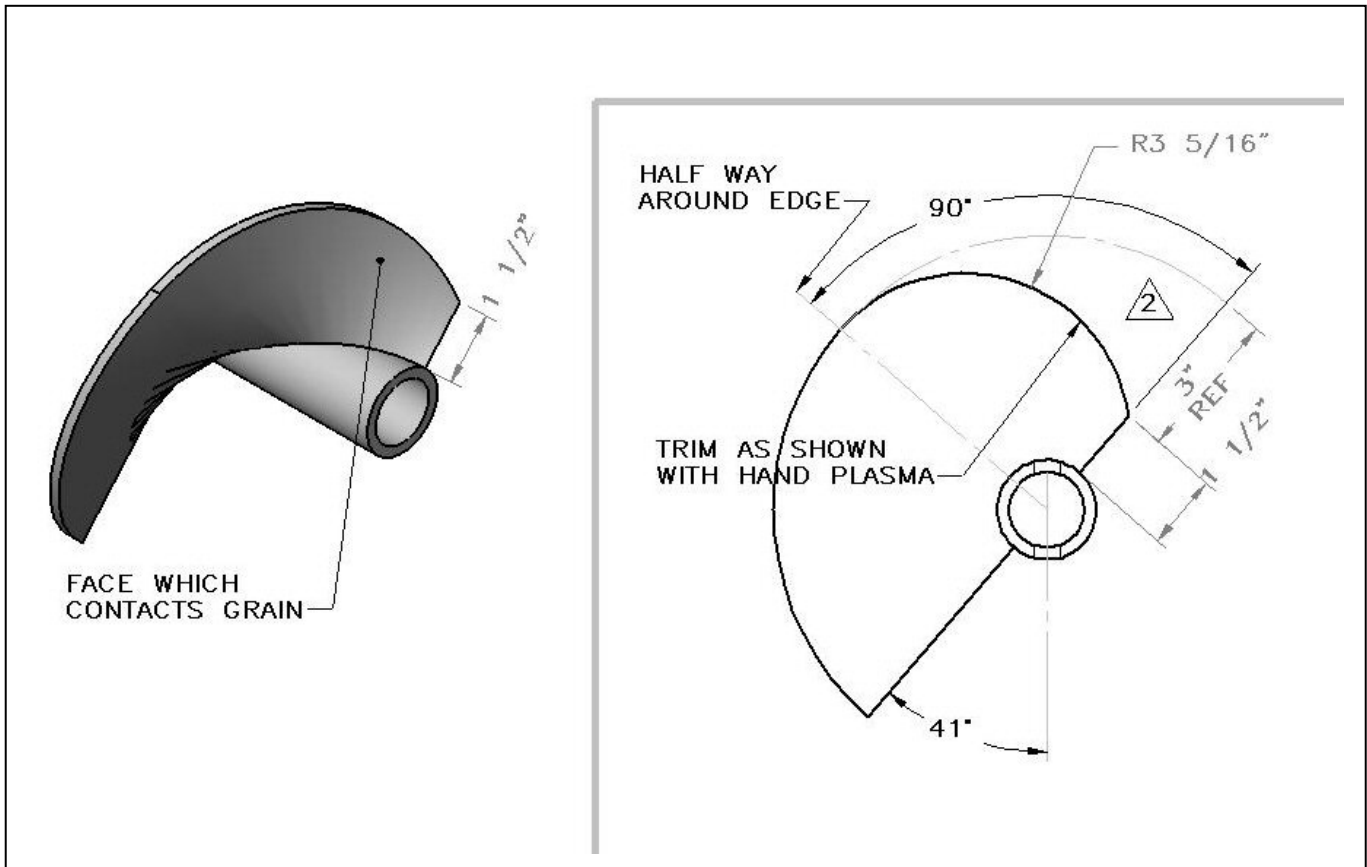
Figure 1

Continuous R&D monitoring and testing combined with customer feedback has shown that removing a portion of the left-hand flighting at the upper end of the top auger section may improve material flow characteristics out of the spring-loaded end dump door, with possible additional benefits of reduced upper flighting wear.

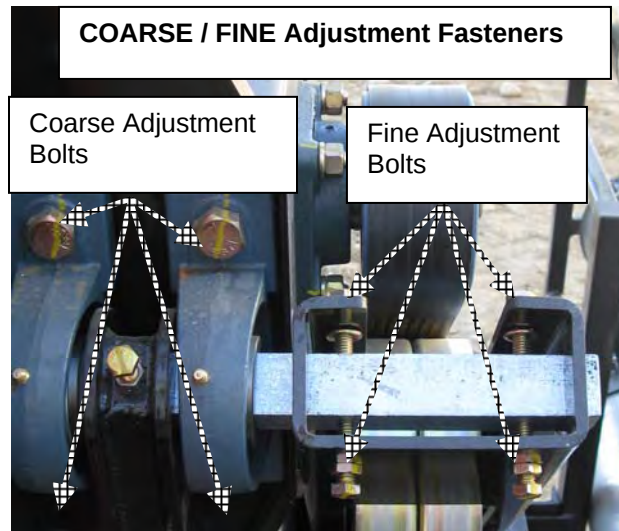
4. Fine adjustment of the idler pulley is achieved by loosening the four 3/8" jam nuts (9/16" wrench) at the top of the box-shaped idler arm, and then using the 3/8" bolts (9/16" wrench) which secure the arm to the square shaft, to twist the arm in the desired direction.
5. Coarse adjustment of the idler pulley is achieved by loosening the four 5/8" bolts (15/16" wrench) that secure the square-bore bearings to the blower h-bracket, and then, while raising or lowering the outer end of the square shaft, re-tightening these bolts.

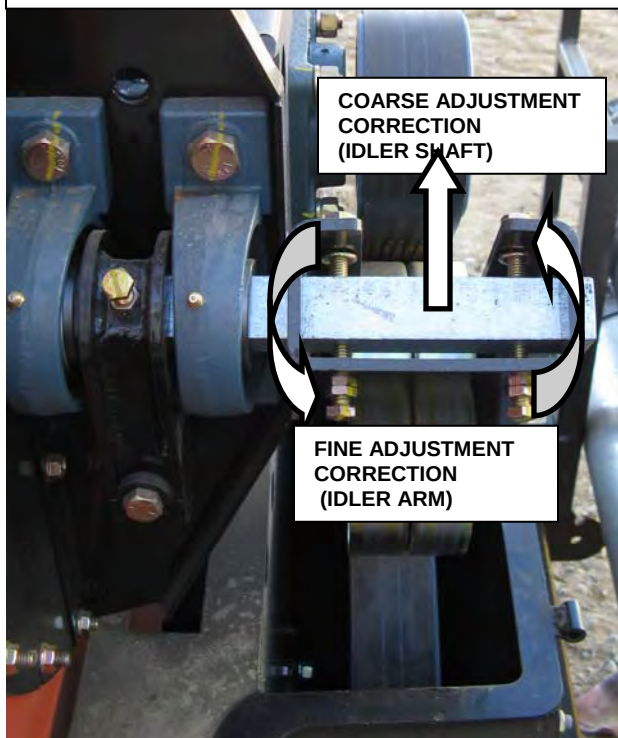
#### Adjustment for Belt Riding Towards REAR

6. If the belt is misaligned as shown, first make the FINE adjustment. If the belt remains misaligned in the same direction, then complete the COARSE adjustment. After completing the coarse adjustment, it may be necessary to repeat the fine adjustment.
7. Following alignment, retighten all fasteners, and rotate the assembly in the normal direction of travel to ensure the belt, where it passes over the idler pulley, is not visible to either side of the belt on the tight side, as per the first photo.

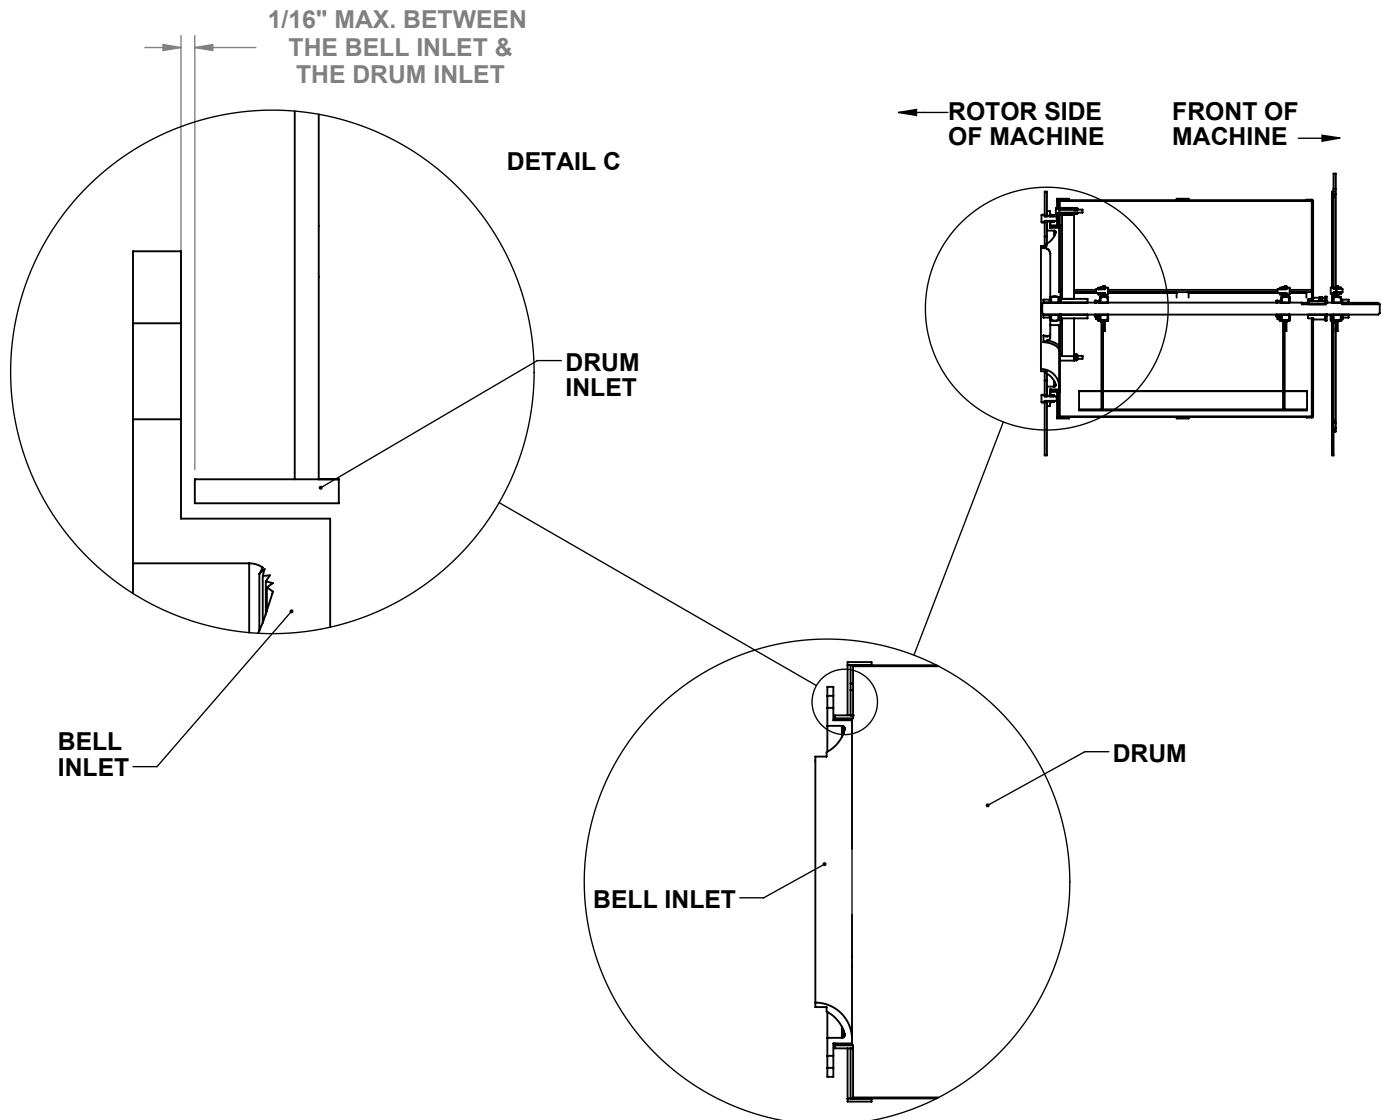
2. AS FOR INSTALLATION OF THE DRUM, IN ORDER TO AVOID FILLING OF THE DRUM WITH MATERIAL, WHAT WE REQUIRE IS A MAXIMUM OF 1/16" DISTANCE BETWEEN THE DRUM INLET AND THE CAST INLET (SEE DETAIL "C").

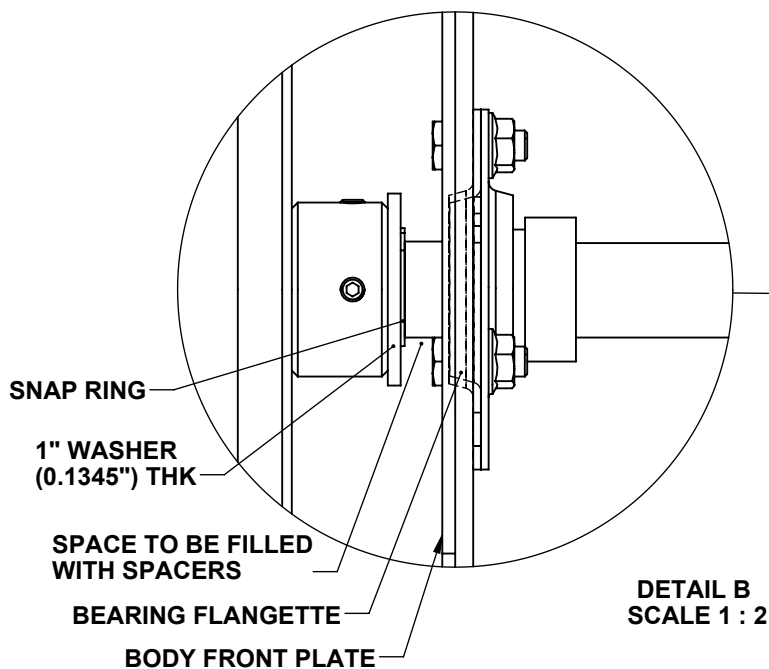
4. ON THE OTHER SIDE OF THE DRUM (SEE DETAIL "B"), THE 5/32" SPACE BETWEEN THE SNAP RING AND THE DRUM HUB SHOULD BE FILLED BY A 1" SAE WASHER (0.1345" THICK, OR MAKE UP WITH STACKING THINNER WASHERS), ONCE THE DISTANCE IS SET THE HUB SET SCREWS SHOULD BE TIGHTENED USING BLUE LOCKTITE AND TORQUEING THEM TO 69 INCH LBS. THE SPACE LEFT BETWEEN THE SNAP RING & THE FLANGETTE OF THE BEARING MOUNTED IN THE FRONT PLATE OF THE VAC SHOULD BE FILLED BY SPACERS/WASHERS SO THE DRUM CANNOT BECOME LOOSE AND MOVE AWAY FROM THE CAST INLET.

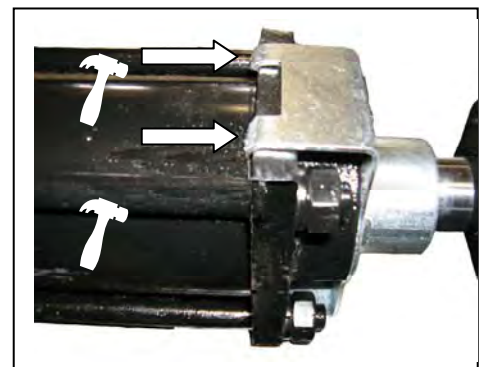
**Figure 1**

1. Detach the top cylinder linkage pin from the top auger tube.
2. Remove the clevis from the cylinder shaft.
3. Fit the cylinder spacer over the shaft as shown in figure 1.
4. Carefully bend the tabs over the end of the cylinder as shown in figure1.

It has been found that the current top cylinder spacer interferes with the hinge mechanism and may cause the cylinder shaft to break.

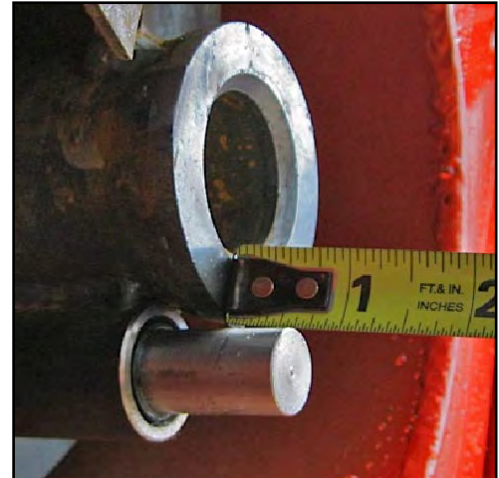
5. Adjust the bolt so that the drive pin is sticking out past the auger washer by 5/8" as shown in the picture.
6. Ensure that the drive pins plunge into the chamber properly.

7. Make sure that your augers are properly adjusted. Apply a straight edge to the bottom of each auger tube and take note of how much gap is in between the end of the tube and the face of the drive dog.  
The gap should be consistent through each section of flyting. If there is not a gap, you may need to loosen off the set screws from the bearing and realign from the bottom section up.

If your customer has the spring loaded drive pin system on their Rem 2700 GrainVac and is experiencing repeated shearpin breakage, clunking or banging in the auger tube, or is burning the front drive belt, they may need to ensure that the drive pins are properly engaging.

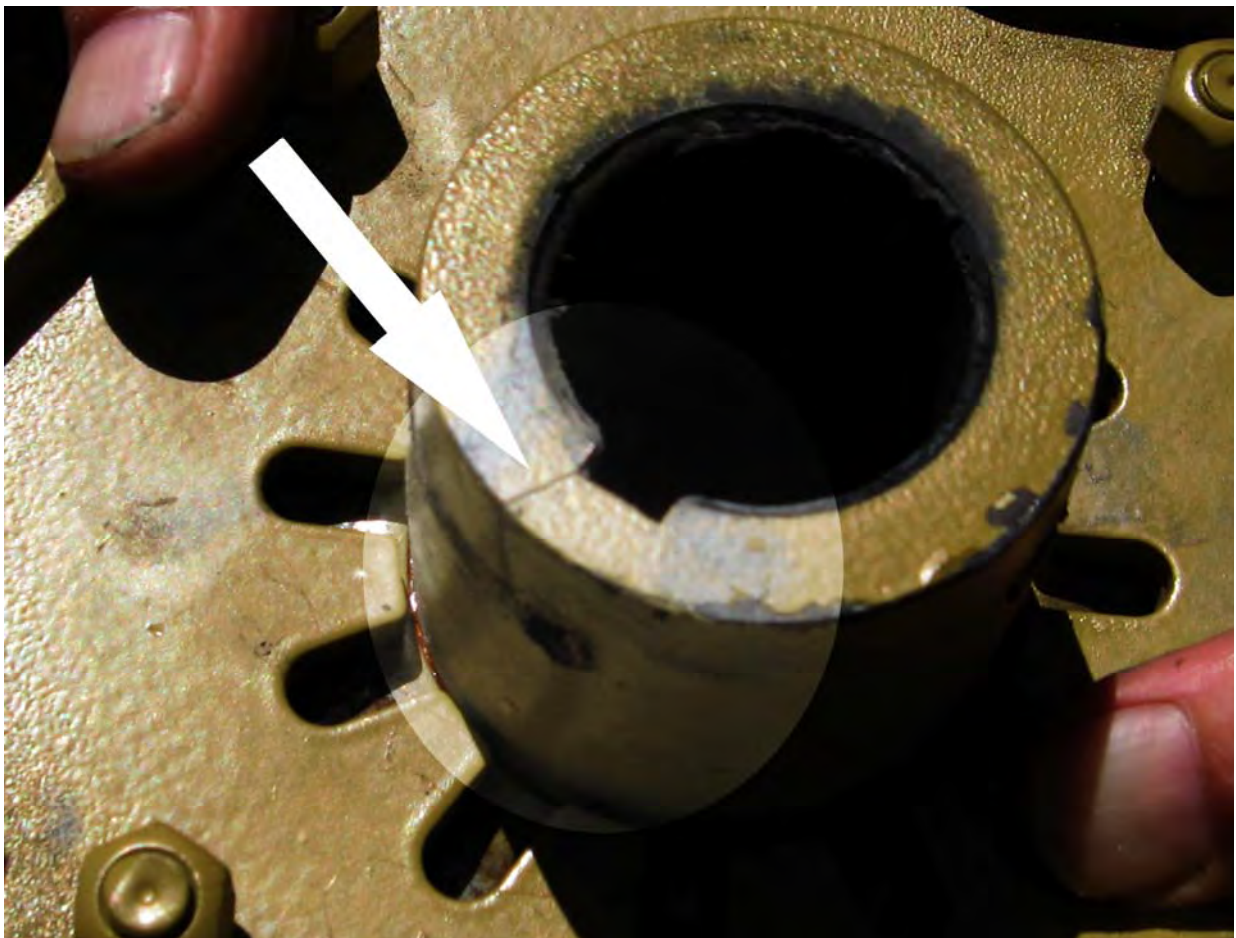
The safety risk has been identified as hairline cracks in the hub on the implement end of the PTO shaft that could result in complete failure. Based on failure tests conducted by the PTO shaft manufacturer it appears that the potential for failure is low. However, if failure were to happen, the implement end of the shaft could disengage from the Vac causing the half shaft to leave the machine at high velocity, creating **a real and substantial risk of damage, personal injury or even death.**

1. Inspect all sold or in-stock 2700 GrainVacs. End users that own units for which a warranty registration has been received will be contacted directly. You must remove the PTO shaft to adequately inspect it. It is essential that you chip the paint away in the region of the keyway and use a magnifying glass or other suitable equipment to detect hairline cracks.
2. Look for cracks or damage on the implement end hub along the edges of the keyway.
3. If cracks or damage are found, call our parts department immediately to order a clutch hub kit. The part number of the clutch hub kit is 7100-37-0276, and installation instructions are included in the kit. Please have the serial number of the unit available when you call. Rem will provide you with the information to file the warranty claim and receive reimbursement.

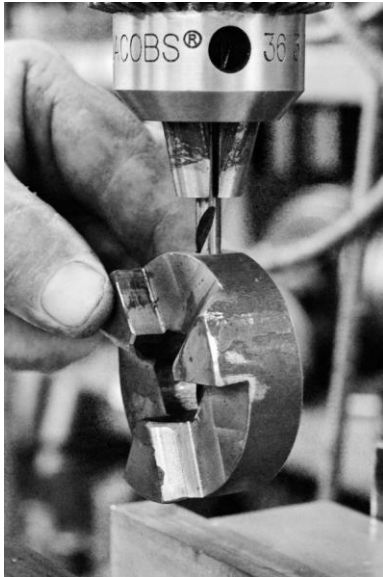
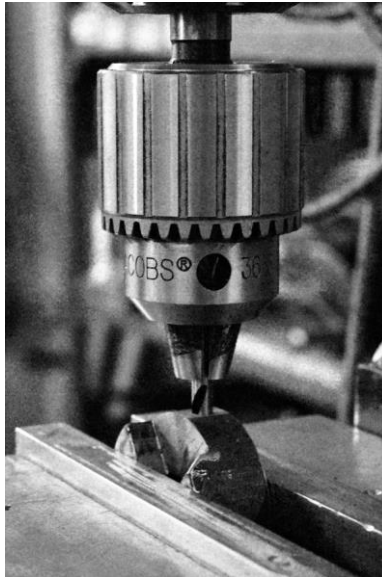
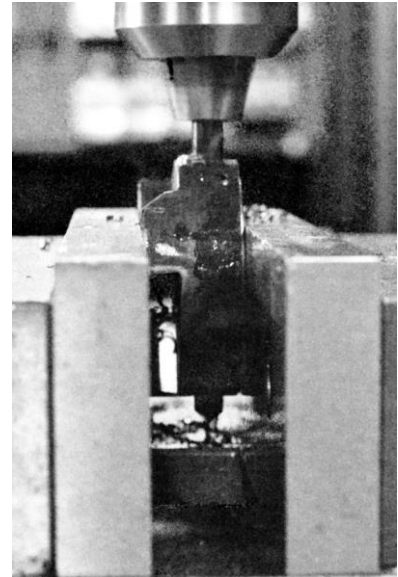
3. Drill out the drive dogs to 21/64" using a drill press. To ensure the hole in the drive dog aligned with the drill bit:

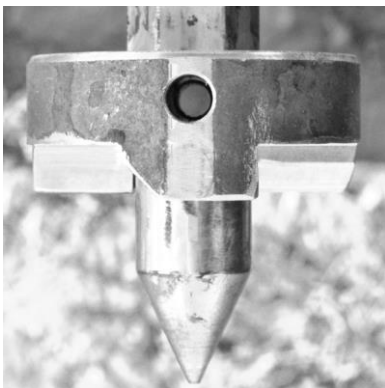
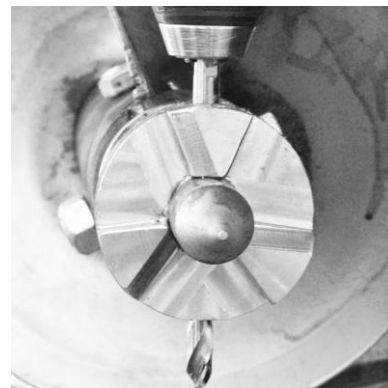
- a. Place a 17/64" bit in the chuck and slide the drive dog onto the drill bit.
- b. Lower the spindle, align the vise, and clamp the drive dog. Raise and lower the spindle and check that the 17/64" bit passes through the drive dog without deflecting. Check that there is enough clearance for a 21/64" drill bit. Readjust positioning if necessary. Once aligned do not move the vise.
- c. Replace the 17/64" drill bit with a 21/64" drill bit and drill through the drive dog.
4. Place the drive dog backs onto the hex shafts and line up the holes.
5. Drill through the hex shaft with a 21/64" drill bit using the drive dog holes as a guide.

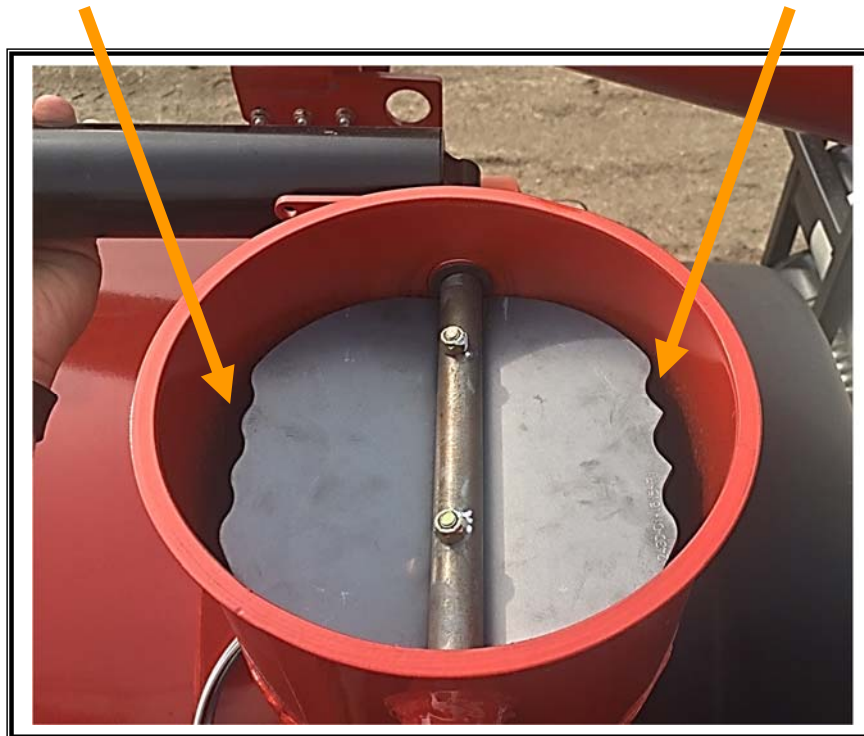
Figure 1: Air Throttle Butterfly – Properly Installed

Smooth waves

Pointy waves

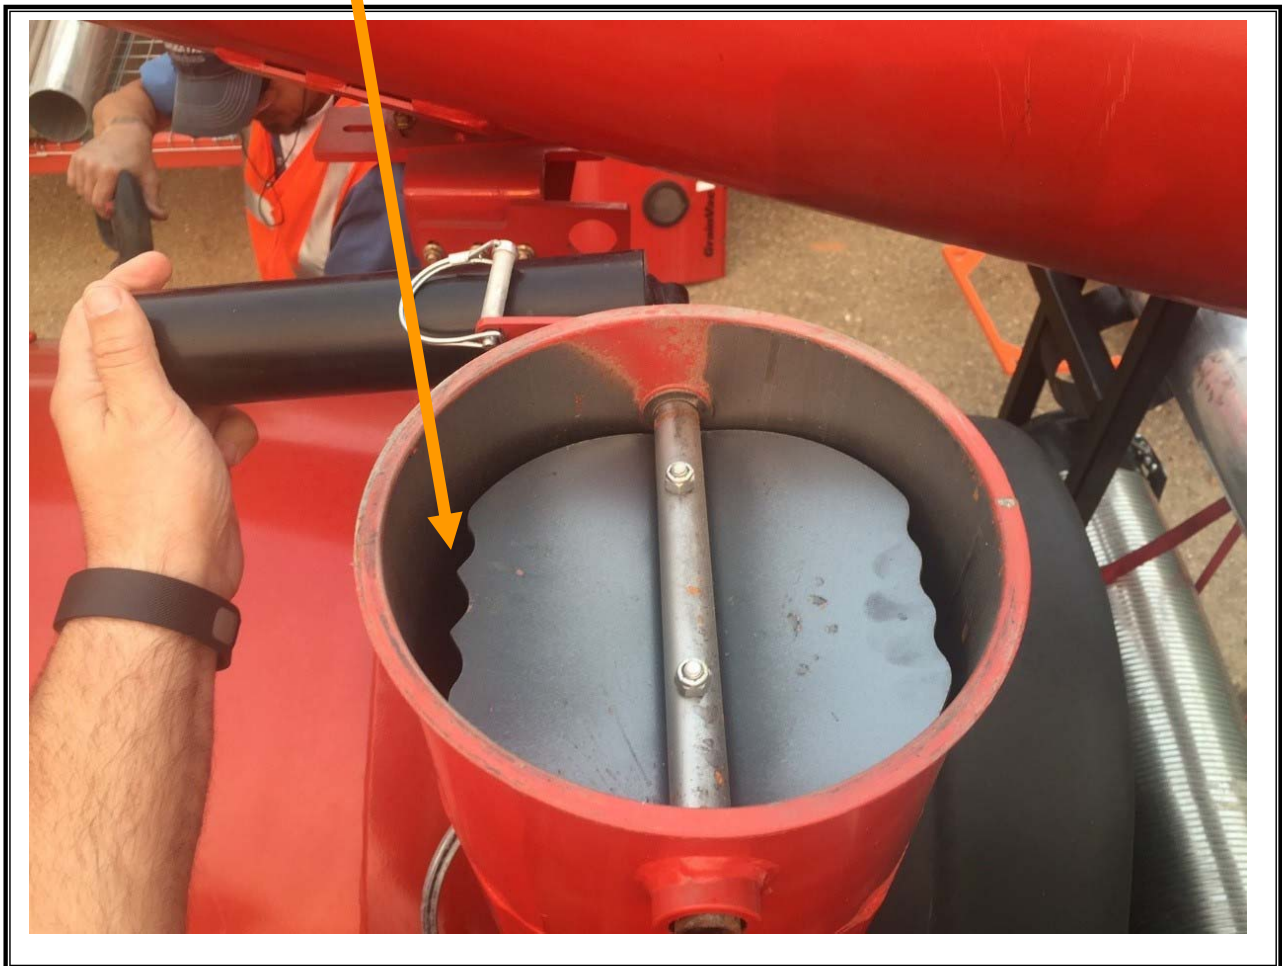
Figure 2 – Air Throttle Butterfly – Not Properly Installed

When the air throttle is in the **closed** position as shown, and the pointy waves are in this position, your air throttle needs to be disassembled, and the air throttle butterfly needs to be turned 180 degrees. See Figure 2.

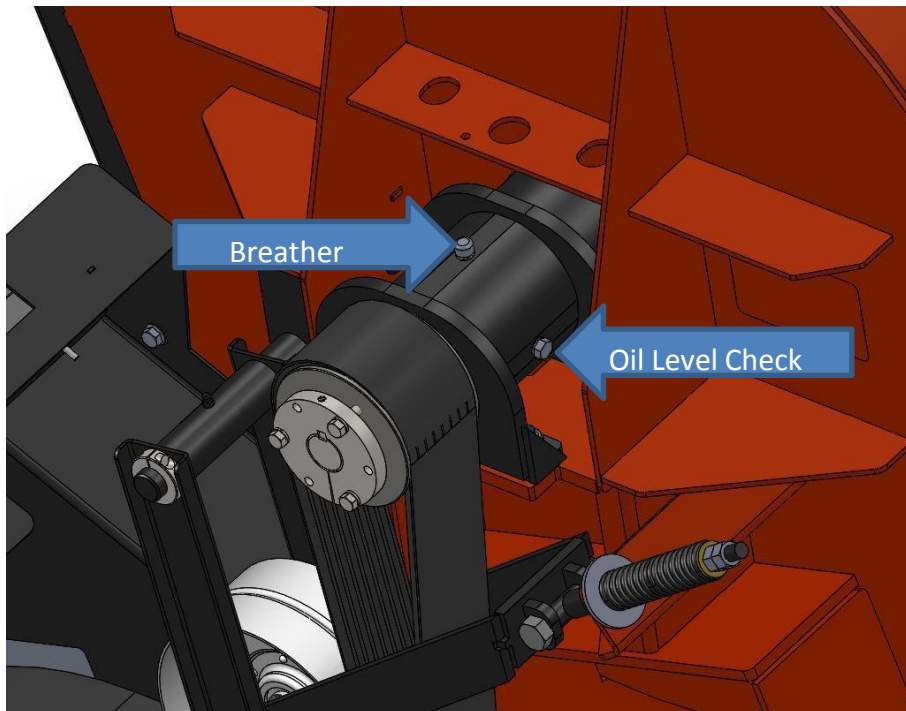
Figure 1: Air Breather and Oil Level Check Plugs

- The rotor bearing cartridge requires SAE 75W90 synthetic gear oil for top-up (if needed).
  1. Place the VR12 on a flat, even surface that will help ensure that the unit is as level as possible.
  2. Remove the hoses from the hose racks.
  3. Remove the rear upper guard to gain access to the bearing cartridge.
  4. Remove the oil level check plug on the side of the bearing cartridge.

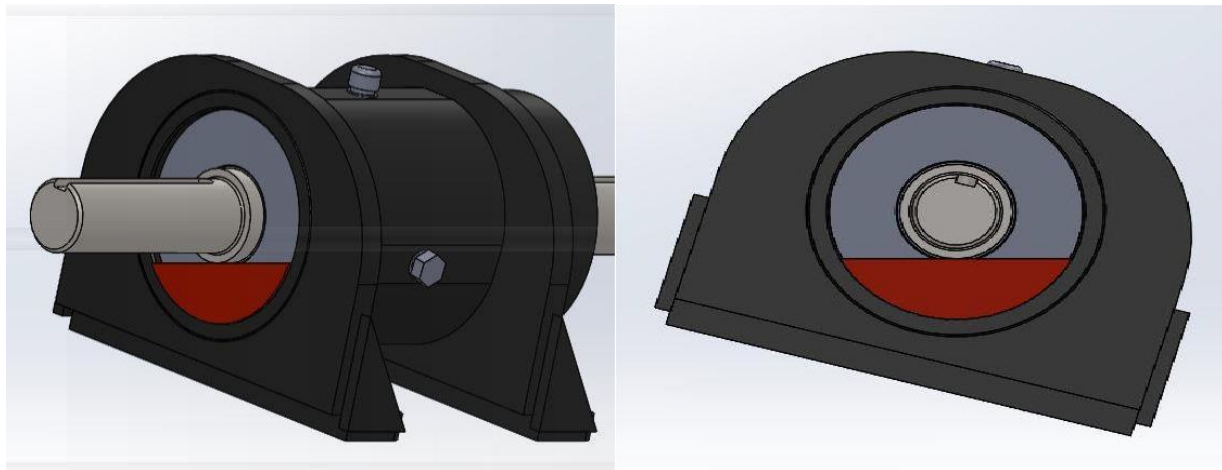
**Figure 2: Correct Rotor Bearing Cartridge Oil Level**

**NOTE:** The oil level check plug measures the correct oil level while the bearing cartridge is installed, at its installed angle (see Figure 2 below).

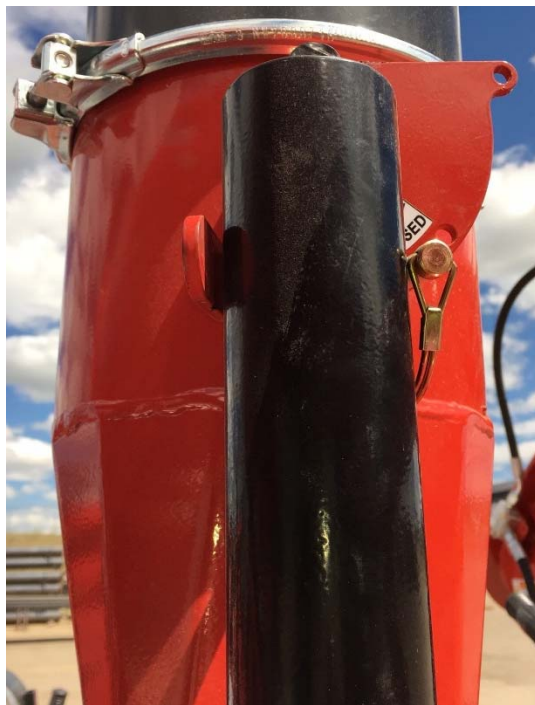
Figure 1:

1. Set the jack on the VR12 so that the unit is sitting level.
2. Check to ensure that the air throttle weight is hanging straight down and gently resting on the stop as shown in figure 1.

We suggest that if you are going to tow the VR12 to different locations, that you lock the air throttle into the open position as shown in figure 1, so it cannot rock back and forth causing the stop to bend again.

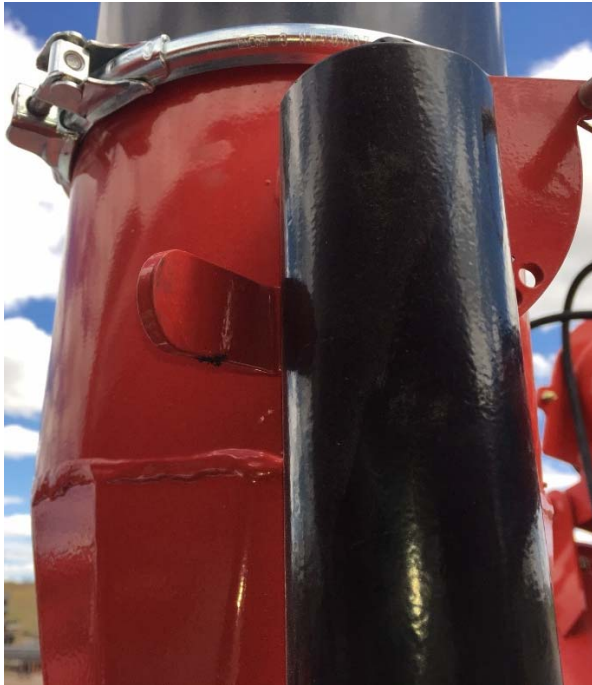
Figure 2:

3. If the air throttle stop is bent as shown in Figure 2, you will have to use a rubber hammer to tweak it back so that it is just touching the air throttle.
